What to Do When Your Cirrus is Mauled

Attack of the Killer Chipmunk: What to Do When Your Cirrus is Mauled

by Matthew McDaniel

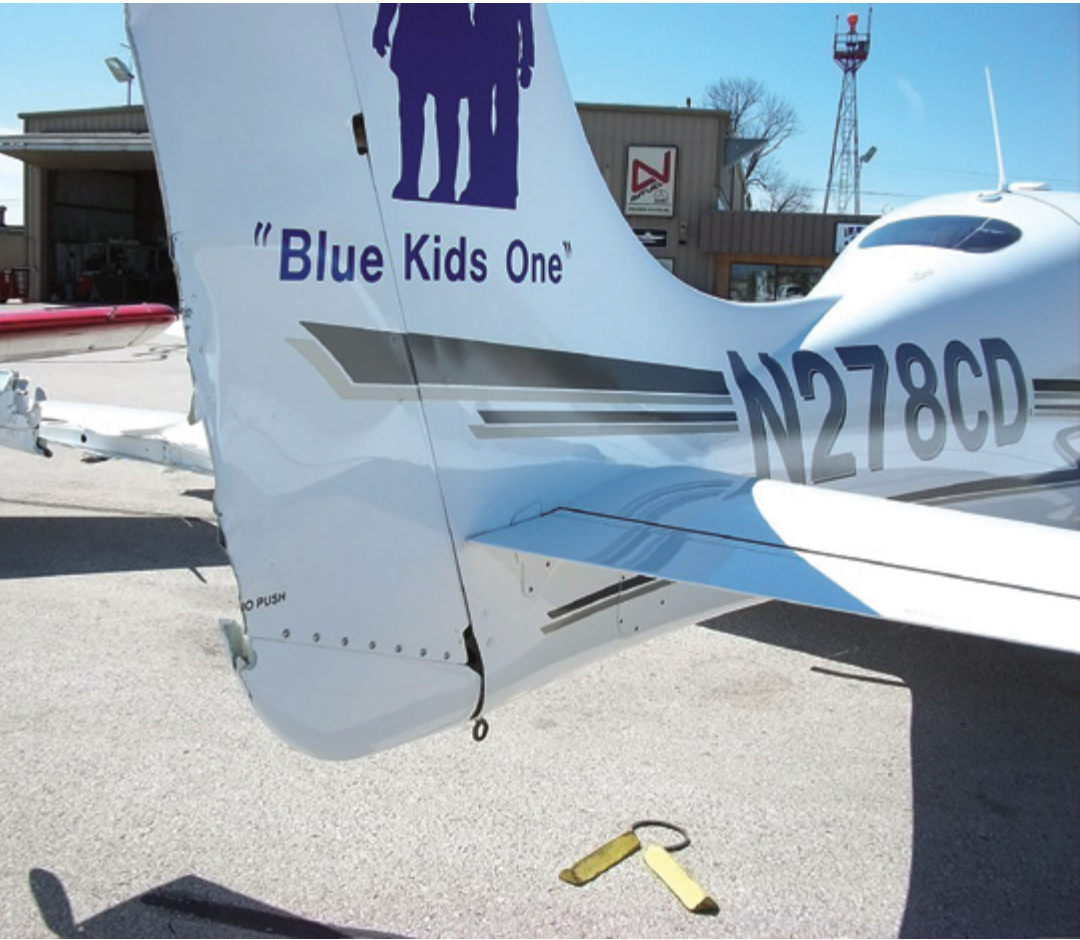
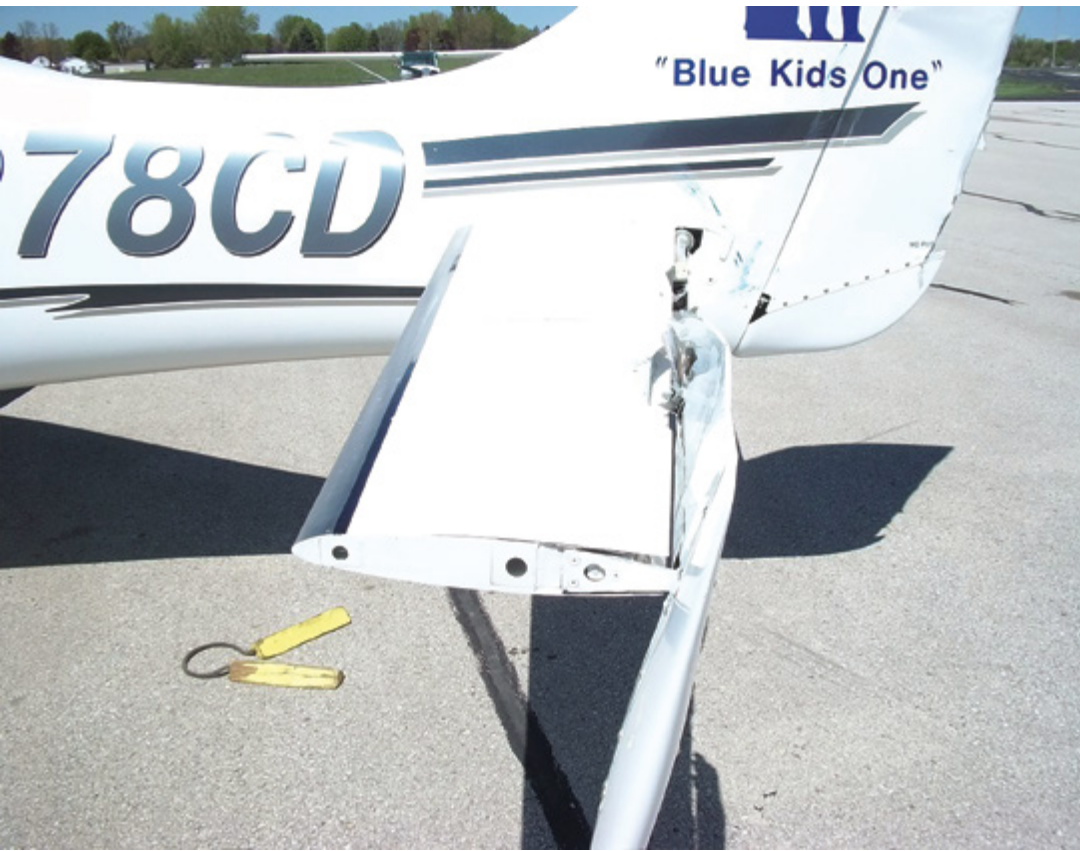
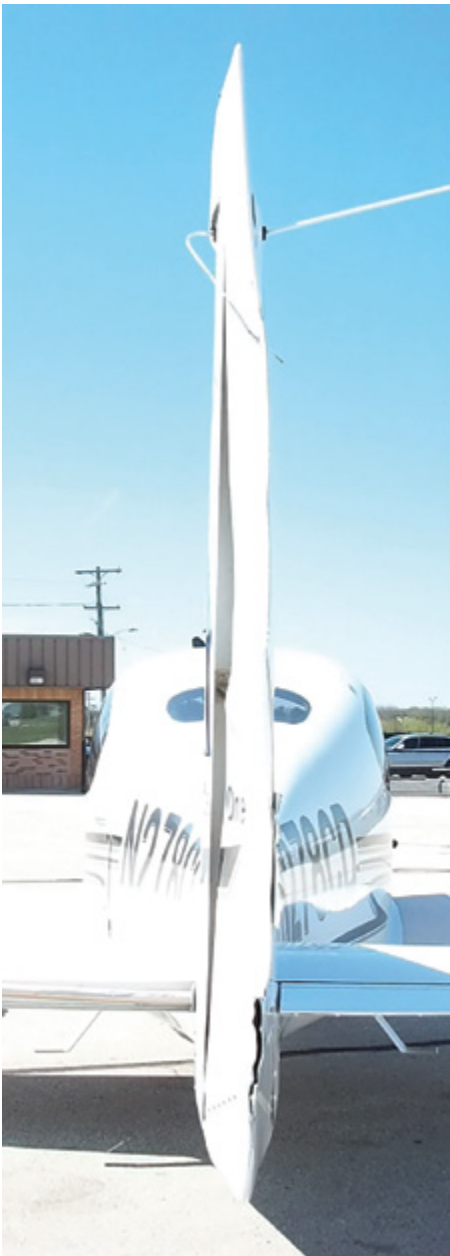
« **Three views of N278CD immediately after the Chipmunk attack.** Note the left elevator is mostly amputated, as is the trailing edge of the rudder. The rudder displays a significant bend to the right and the left half of the VOR antenna has been bent and skewered through the rudder. In one view, the left wingtip of the Chipmunk is in view.

The Cirrus' left elevator was partially amputated from the empennage. The rudder was bent and gashed. The left side of the vertical stabilizer had a small cut in the composite near the top and the adjacent VOR antenna was twisted

and literally pierced through the upper rudder. A few small gashes scarred the aft fuselage and the vertical strake, which blends the fuselage into the vertical stabilizer. One item to be thankful for was the Chipmunk's new prop featured composite blades, which absorbed as much impact damage as the Cirrus tail did. Chances are, if it had been wearing its previous all-metal prop, damage to the Cirrus would have been much greater.

So, everyone agreed that going with a more predictable route would be best, even if that meant added complexities in the repair process. It was thought better to proceed with a total replacement of the rudder, both elevators, the entire horizontal stabilizer, and associated components rather than trying to salvage

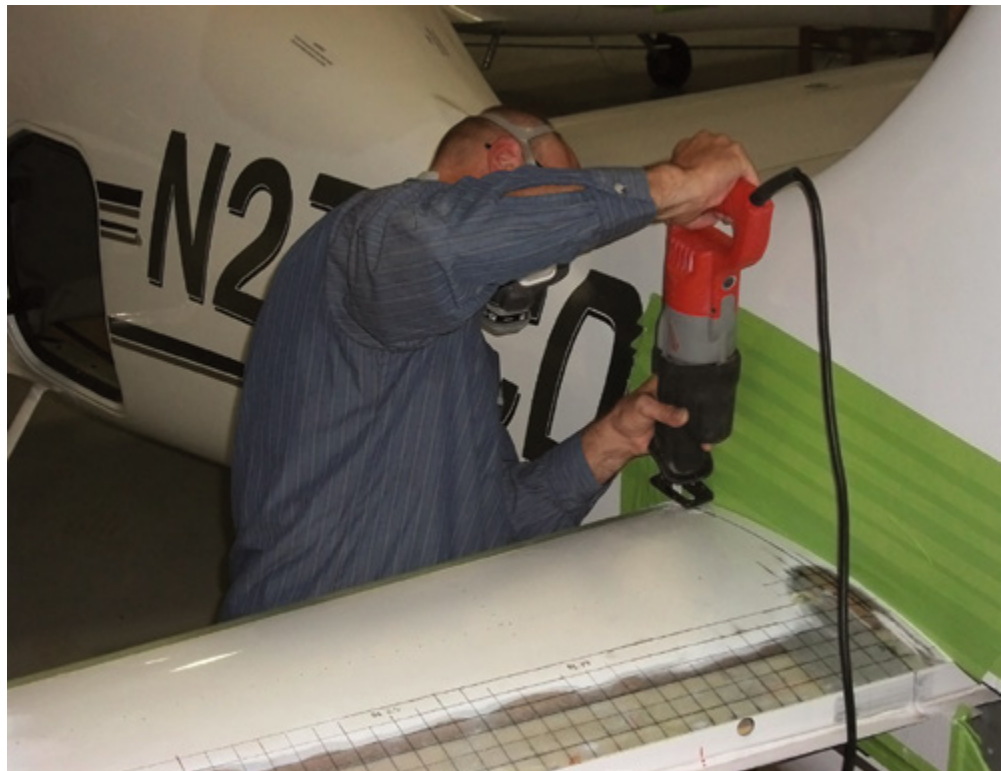
» A Wisconsin Aviation technician uses a Sawzall to cut off the left horizontal stabilizer after the decision was made not to attempt to repair it. Instead, a brand-new horizontal stabilizer, built by Cirrus Aircraft, would be installed.

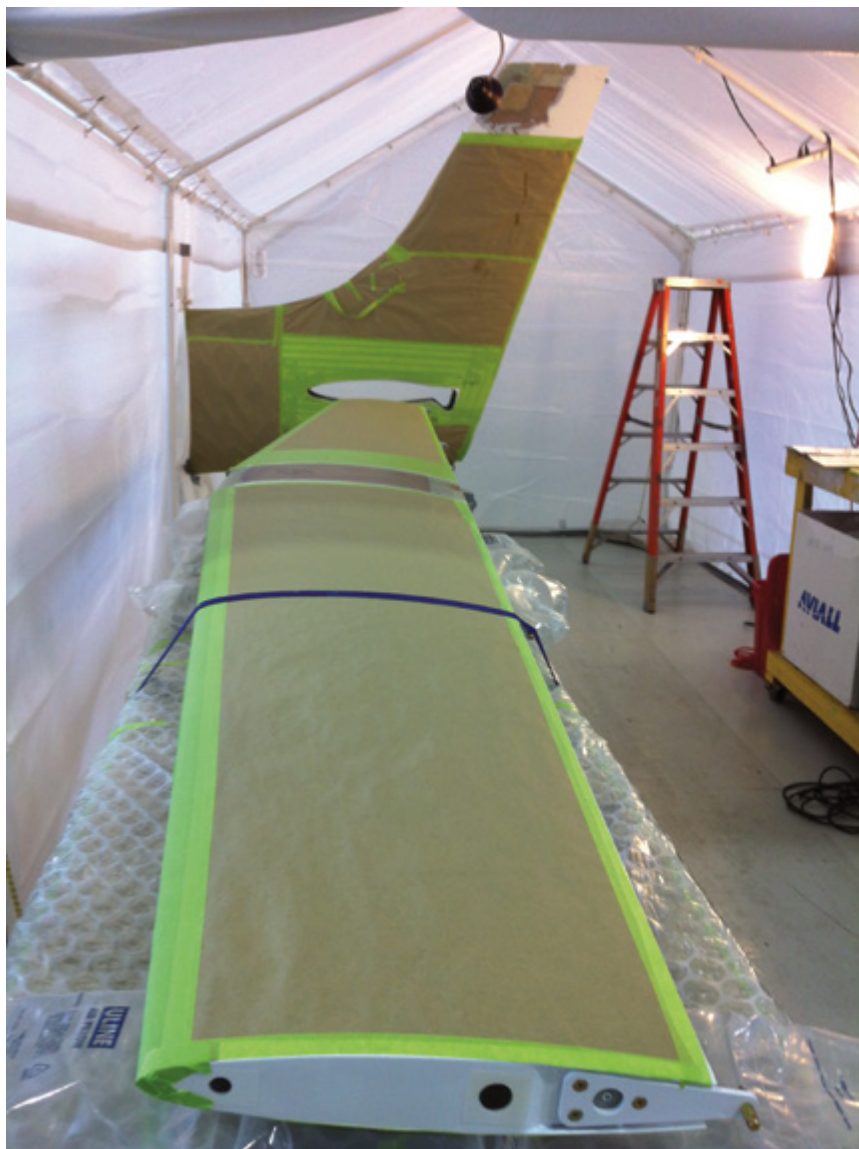
« **Taken within the temperature and humidity booth** specially built to complete major structural composite repairs to the aircraft's empennage. The new horizontal stabilizer is ready to be inserted through the fuselage. Note the completed composite repair at the top of the vertical stabilizer curing under a heat lamp. The CSC was careful to protect the paint, as the plane was not to be entirely repainted, but repainted only in the areas requiring it and blended as necessary.

bonded in place, along with completing the other minor composite repairs. That was where the CSC's facilities became a problem. Wisconsin Aviation didn't have a temperature and humidity-controlled space, and during Wisconsin summers, both those environmental factors can vary greatly over small spans of time. They built an environmentally controlled booth inside their maintenance shop and sealed 278CD's entire tail section inside it. Within this work area, the temperature and humidity could be closely regulated, and the composite repairs and bonding processes carried out to the exacting standards required.

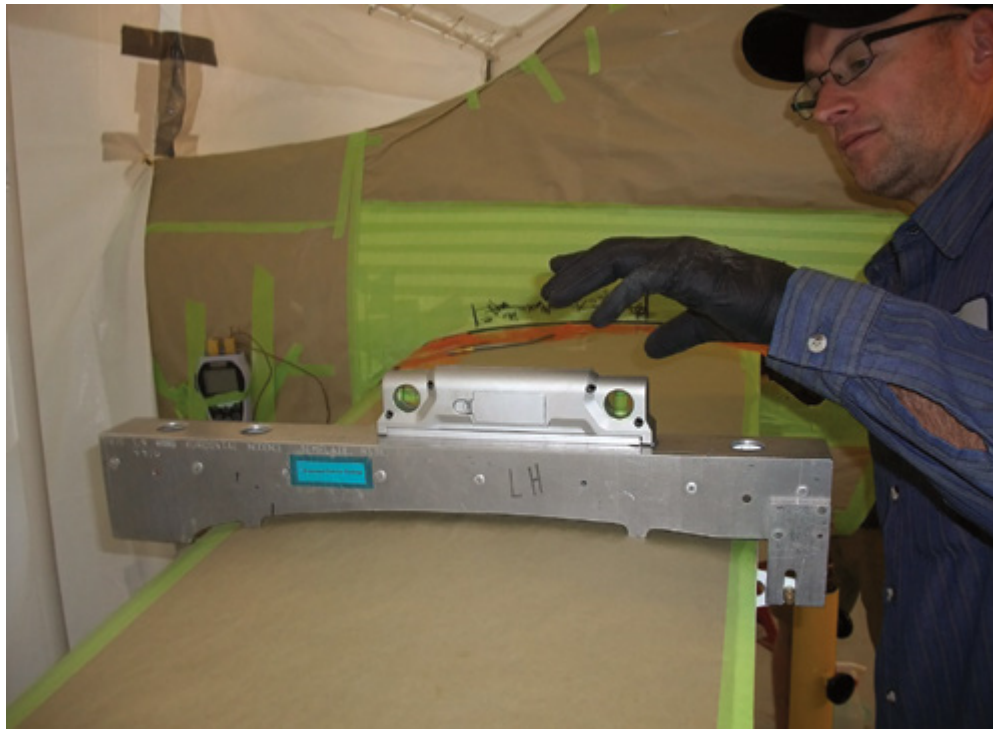
» **A tech takes precise measurements** before the position of the horizontal stabilizer is finalized and permanently bonded in place. This process was the most critical of the project to ensure the plane conformed to factory-new standards and would fly as it had previously.

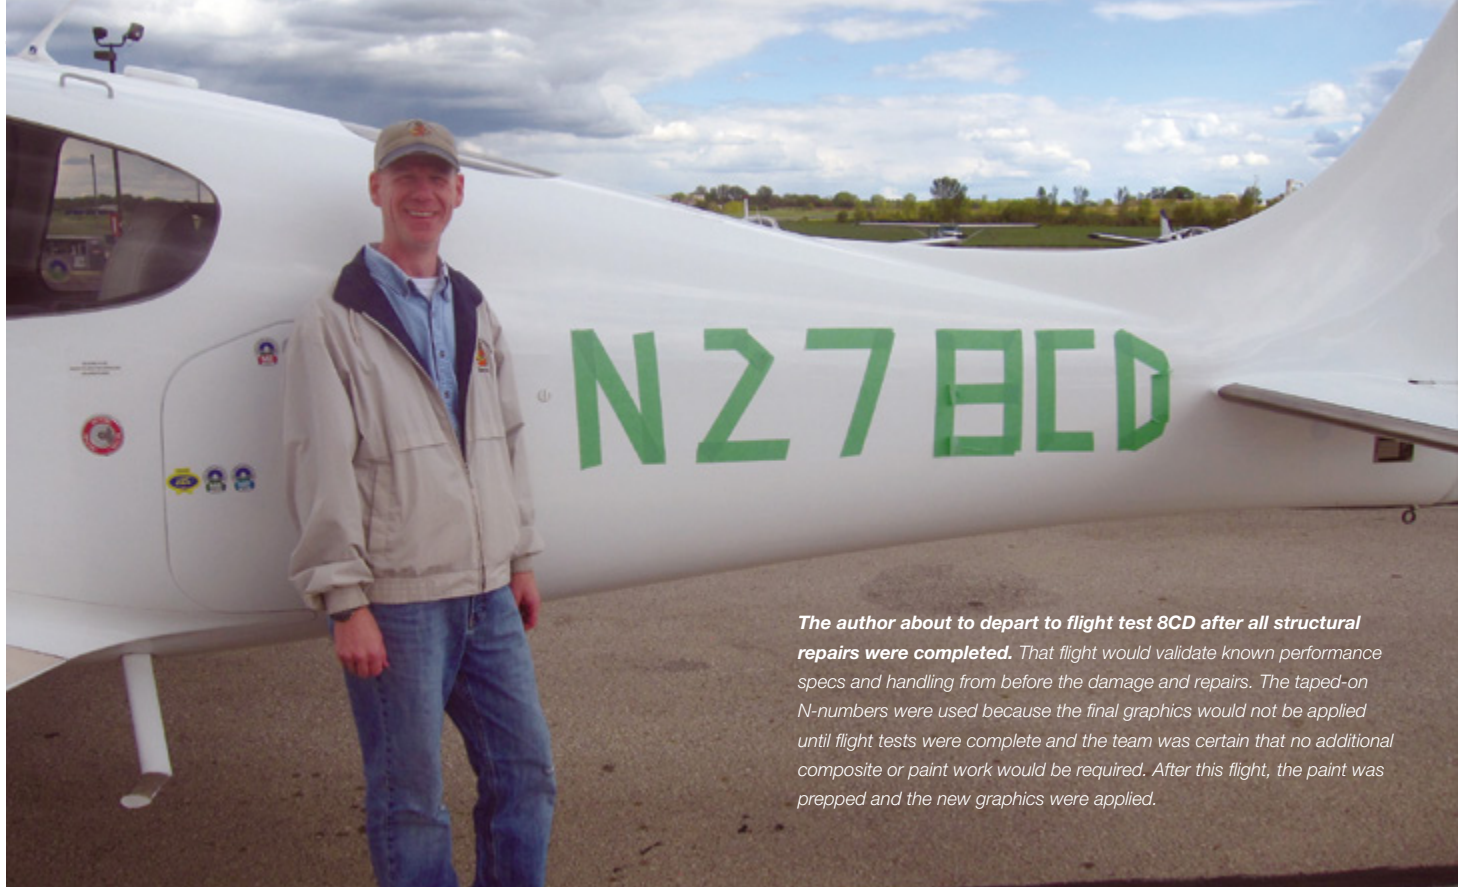
The author about to depart to flight test 8CD after all structural repairs were completed. That flight would validate known performance specs and handling from before the damage and repairs. The taped-on N-numbers were used because the final graphics would not be applied until flight tests were complete and the team was certain that no additional composite or paint work would be required. After this flight, the paint was prepped and the new graphics were applied.

after various upgrades were installed, and flew the aircraft for some personal use, they felt I knew their SR22 as well as anyone. We agreed upon a test profile I would fly to verify the aircraft still achieved its known performance history and handling characteristics, etc. That test flight also proved uneventful, and all that remained to return it to the skies was to install the updated graphics and registration numbers.
