No Time To Spare:

Catastrophic

Oil Loss

MATTHEW McDANIEL recounts a harrowing incident where his taildragger suddenly lost engine oil mid-flight in freezing conditions, and how this close call led him to review and change his cold-weather flying procedures.

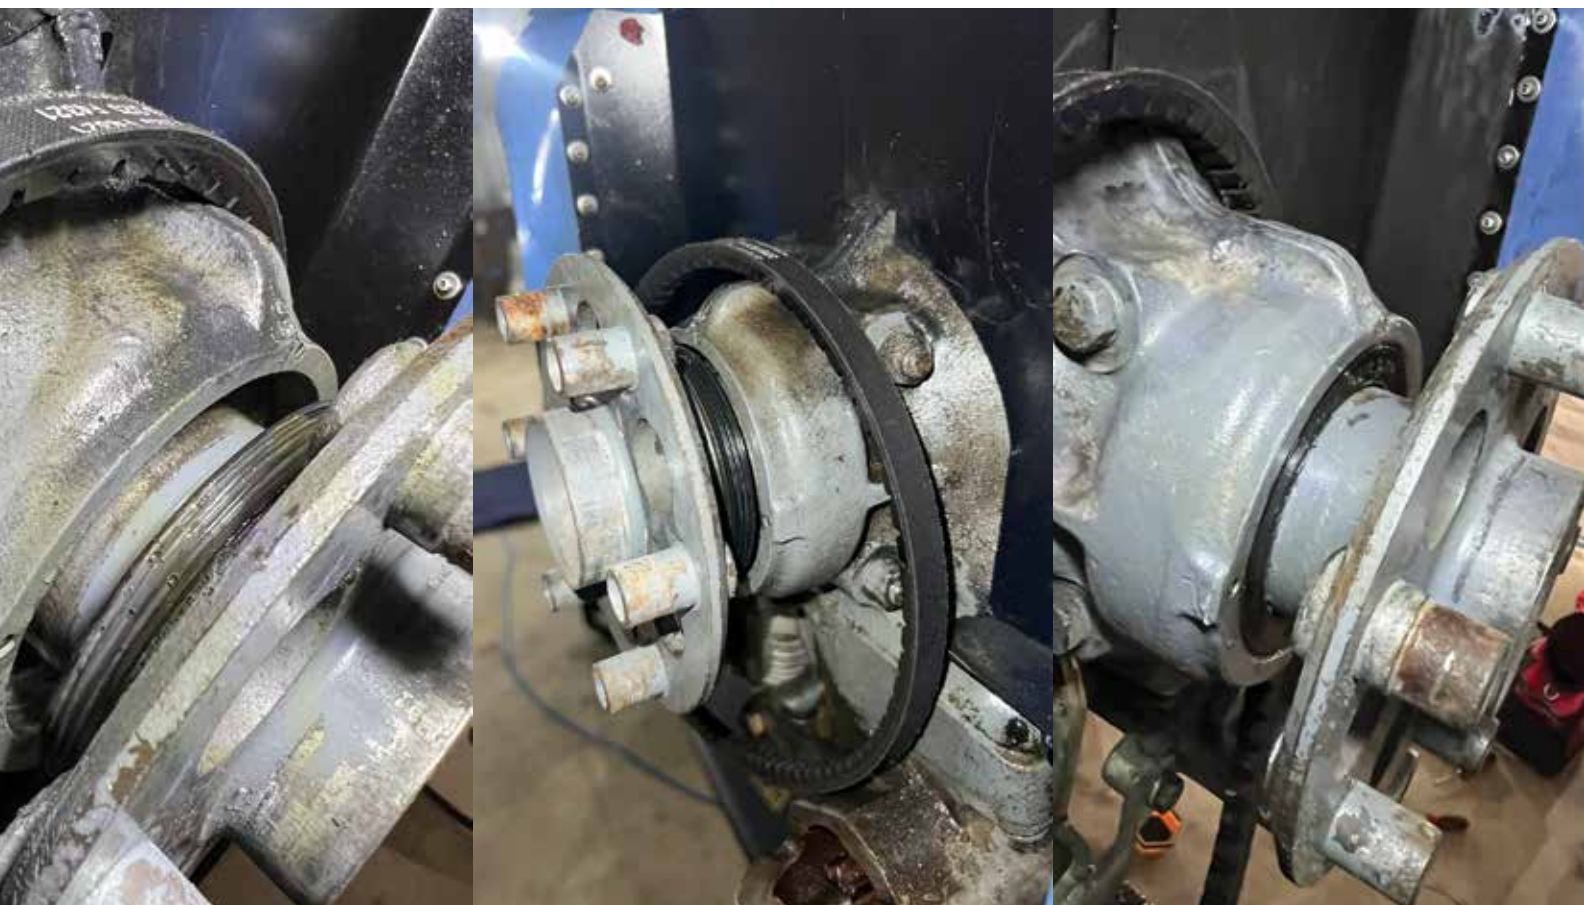
In what must have been mere seconds, I realized it was neither heater odor I smelled, nor freezing breath I saw. It was very faint white smoke and the smell of burning oil.

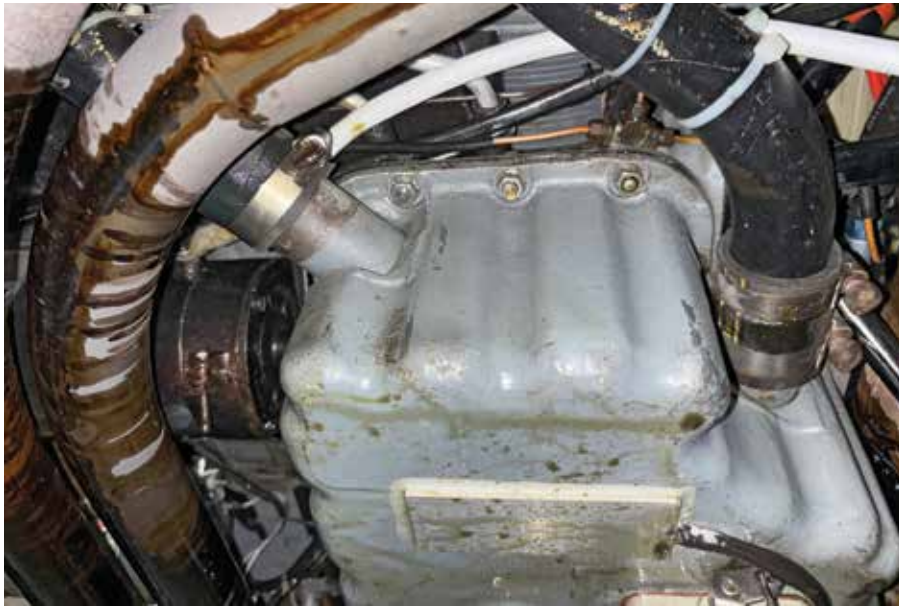
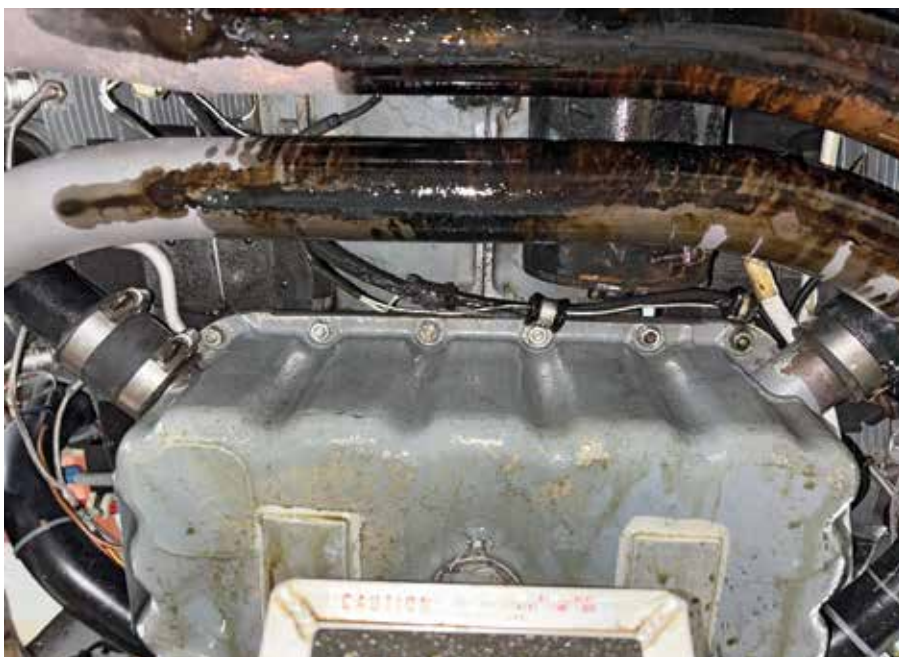
The puddle of oil was already substantial and growing, fed by a steady stream from the lower cowl. The right side and nose bowl were clean. But the left side had oil seeping through the joint where the upper cowl overlaps the lower. The left gear leg was coated with oil and the belly was a slimy mess. My first thought was that I must have blown an oil line. Then, I considered a possible problem with cylinder No. 1 (adjacent to the oil oozing from the cowl side). So, I opened the left side of my clamshell cowl, finding oil splattered everywhere. Yet, try as I might, I could not find a disconnected or compromised

Before we even met at the hangar, my mechanic said he had a pretty good idea what the problem was. First, he diligently checked the oil hoses/fittings and looked for leakage in other areas. But, the oil streaking under the spinner (that I'd decided not to clean) was the big clue. He'd suspected the crankcase nose seal had failed, which would account for the oil oozing from behind the spinner and the copious amounts of oil inside the nose bowl and on the adjacent exhaust pipes. After a bit of a struggle to get visual access, he was able to confirm the seal was, indeed, the culprit. But, all that could be seen was that it was out of its seat, protruding outside the crankcase.

Knowing that, the root cause was still mysterious. Had the seal ruptured, split, or simply been pushed outward? Had the crankcase over-pressurized, forcing an intact seal from its seat? The former option seemed the most likely, given the engine's advanced age and the fact the breather line wasn't blocked.

When the mechanics returned, they barely applied any pressure to the crankcase seal with their hands, and it slipped aft and popped back into its seat on its own. Thus, it didn't appear to have any significant rupture. It was cut and removed anyway and the new one was installed, as it was obviously not sealing in place properly anymore. Once that was done (via the engine manufacturer's guidelines), the new seal and the RTV applied around it were allowed to cure for several days (with the engine heater still on to keep the metal well above ambient temperature).

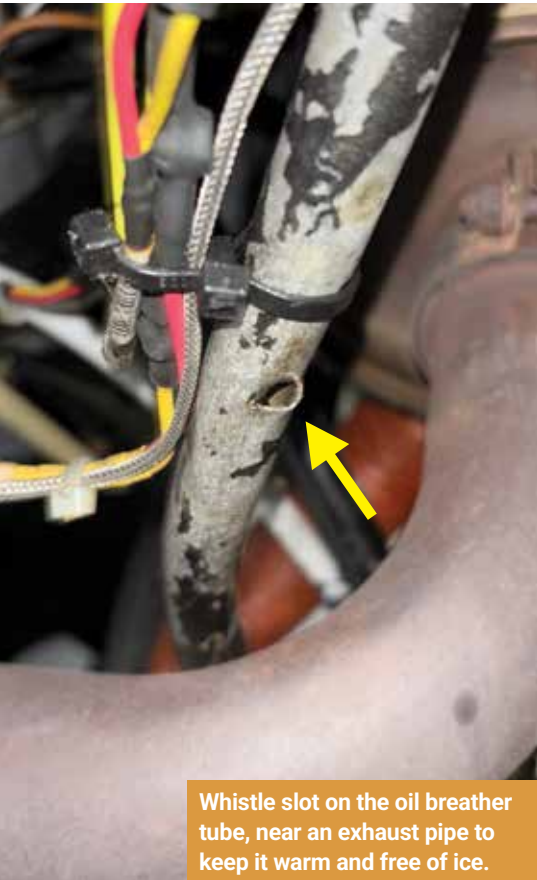
Whistle slot on the oil breather tube, near an exhaust pipe to keep it warm and free of ice.

Upon removal of the upper breather line, no blockage was found within it. However, if that blockage had been ice, the evidence would have melted away long before. So, the AOS was removed and disassembled. While air would pass through it and no debris was visible when peering inside, it was decided to soak it in fuel to clean it thoroughly. In short order, the fuel discolored and significant debris appeared. The AOS might not have been fully clogged, but it also was not “breathing” at its designed capacity.
