No Time To Spare:

Catastrophic

Oil Loss

MATTHEW McDANIEL recounts a harrowing incident where his taildragger suddenly lost engine oil mid-flight in freezing conditions, and how this close call led him to review and change his cold-weather flying procedures.

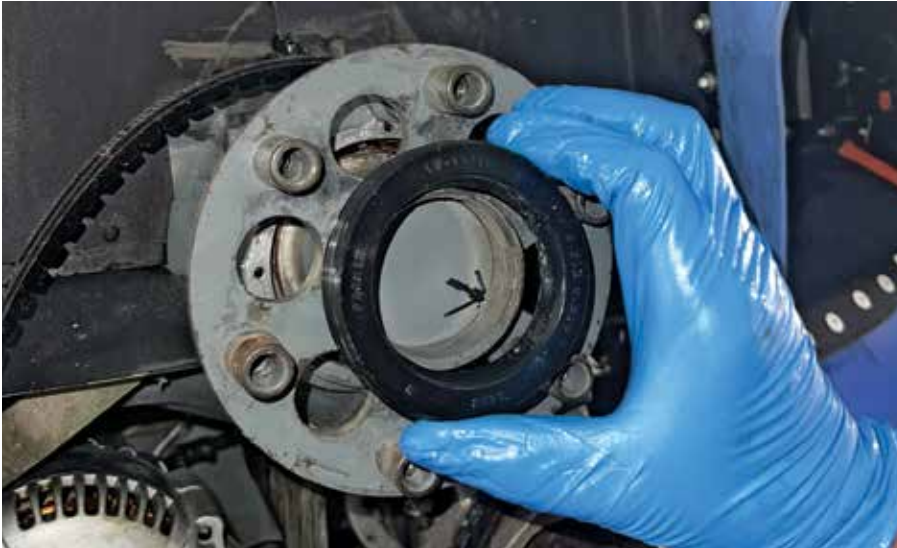
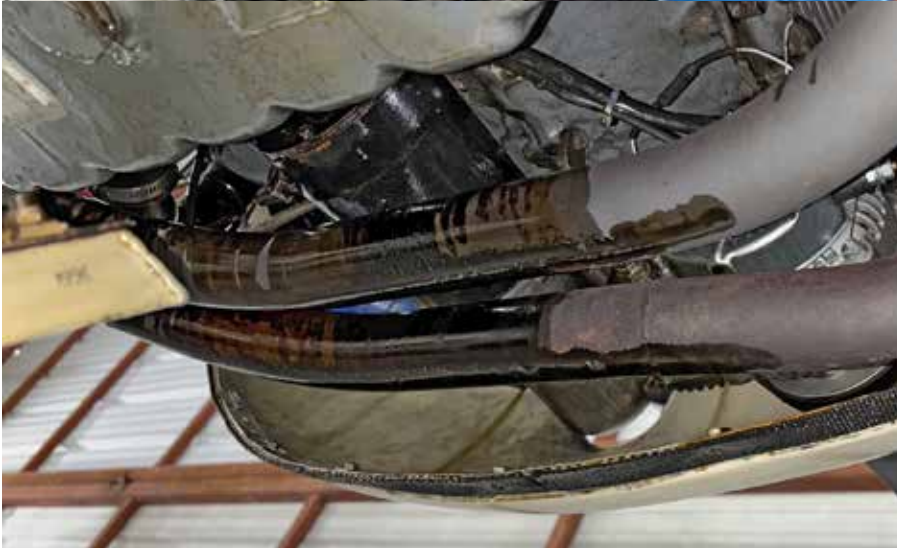
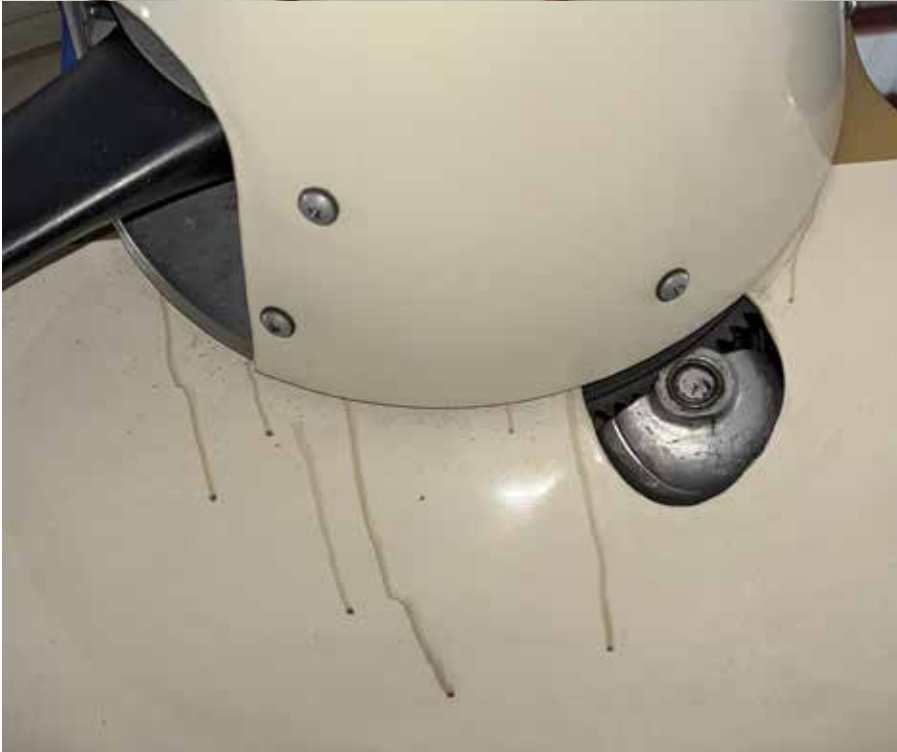
In what must have been mere seconds, I realized it was neither heater odor I smelled, nor freezing breath I saw. It was very faint white smoke and the smell of burning oil.

Before we even met at the hangar, my mechanic said he had a pretty good idea what the problem was. First, he diligently checked the oil hoses/fittings and looked for leakage in other areas. But, the oil streaking under the spinner (that I'd decided not to clean) was the big clue. He'd suspected the crankcase nose seal had failed, which would account for the oil oozing from behind the spinner and the copious amounts of oil inside the nose bowl and on the adjacent exhaust pipes. After a bit of a struggle to get visual access, he was able to confirm the seal was, indeed, the culprit. But, all that could be seen was that it was out of its seat, protruding outside the crankcase.

Knowing that, the root cause was still mysterious. Had the seal ruptured, split, or simply been pushed outward? Had the crankcase over-pressurized, forcing an intact seal from its seat? The former option seemed the most likely, given the engine's advanced age and the fact the breather line wasn't blocked.

In the end, the cause was likely a perfect storm of events, none of which would likely have led to the event singularly. However, the cumulative effects of two or more events perfectly aligning could very well have been sufficient to cause the over-pressure of the crankcase, thus blowing out the nose seal. Here are the events that may have contributed:

- No engine preheating was used, which would have likely melted that ice (if it ever existed), given sufficient time.
- A partially clogged AOS likely allowed air to pass through at something less than full capacity, even without an icing component. Combined with icing, significant blockage may have resulted.
- A crankcase seal that could very well have been original to this engine (manufactured in the 1970s) and compromised by age alone. While the seal had not ruptured, it could very well have aged to the point of being less capable of resisting slight over-pressures without becoming unseated.

After the new seal had cured, the engine was leak-checked via extensive ground runs, up to and including full static RPM. Thereafter, it was flight-tested above the airport in various attitudes, speeds, and power settings, and all was normal. The aircraft is now back to fully operational status, has flown in temps ranging from 45 F down to 0 F, and no lasting ill effects have been noted.
